# Works of Art, Produced from Concrete, Installed in Public Spaces from the 1950's to the 1980's in the former Czechoslovakia – Technologies and Surveys

Josef ČERVINKA<sup>1)</sup>

<sup>1)</sup> University Pardubice, Faculty of Restoration, Jiráskova 3, 570 01 Litomyšl, Czech Republic

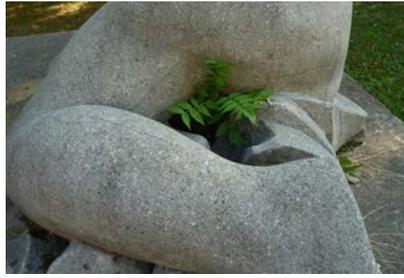
Fig. 1. Alois Šutera, Hudebník (A Musician), 1971, green-engrained concrete filled with basalt aggregate. Photograph Josef Červinka

The sculpture *Cimbalista* (A Cimbalom Player) by Miroslav Hudeček, situated in Strážnice, and *Hudebník* (A Musician) by Alois Šutera are examples of this category. The sculpture *Hudebník* by Alois Šutera was created in 1965 (10), now is located in the Přerov cemetery memorial park, where was most probably fixed in 1971 (11). The work depicts a stylized figure of a seated musician, playing the mandolin. The statue is made as a monolithic casting piece with metal reinforcement with the height 125 cm, width 50 cm, and depth 61 cm. Sculptural mass consists of green-engrained concrete

filled with basalt aggregate. Aggregate, size 0–4 mm with high density 2,700 kg/m<sup>3</sup> and content of magnetic particles, corresponds with the locality Bílčice (12). The sculpture is reinforced with three types of reinforcing bars. The first bar has a square cross-section with 10 mm sides and is located in the axis head – pedestal, then in hands and legs. A round cross-section reinforcement (6 mm) reinforces mandolin, fingers, and pedestal ledge. Third type of reinforcement (unidentified cross-section) with minimum dimension 15 mm, is in the trunk and pedesta (13). Sculpture surface is biologically-attacked, mainly by mosses. As to the mechanical damages, destruction of concrete caused by the steel reinforcement corrosion is dominant. Concrete mass is cracked, some parts of modeling fell away; moreover, some parts are loosed and separated from the steel reinforcement. In the past, three types of repairing mortars were used to repair the sculpture. The roughest type is used on the sculpture knee; light, from grey cement not engrained in the mass to the green shadow as in case of the authentic mass, but containing the same basalt aggregate. Other two types of mortar are very fine-grained. The first looks like the binding agent of the authentic mass without basalt chip stones and the second one is without engrained cement binding agent, containing small green chip stones. Both types of fine repairing mortars can be clearly seen in UV light.

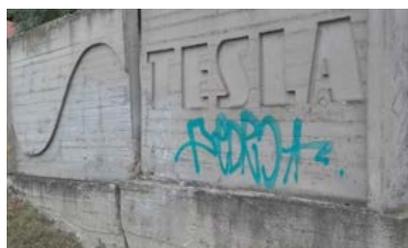
Fig. 5. Jánuš Kubíček, decorative wall, Halasovo náměstí Brno, 1967, example of the object from raw concrete with imprints of wooden boarding. Photograph Josef Červinka

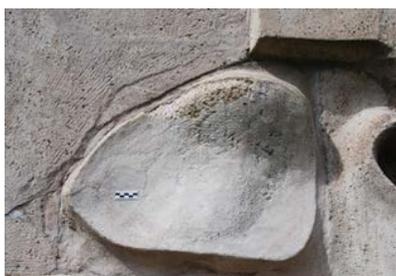
Fig. 6. Detail of wooden boarding imprint including joints between individual boards. Photograph Josef Červinka

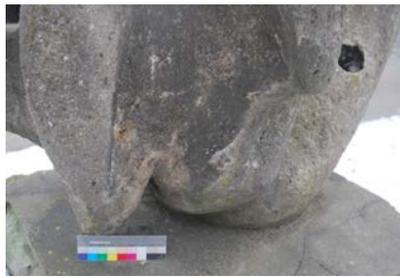
Fig. 7. Miroslav Jirava, Torzo ženy (A Female Torso), Prague Jarov, 1965, example of the object from concrete applied on the steel reinforcement covered with ceramic mesh. Photograph Josef Červinka

Objects, created by application of concrete to the steel structure thickened with various types of mesh, represent a specific phenomenon. They belong into the group of objects, most commonly created in situ. The artworks “Lovec sobů” (A Reindeer Hunter) by Antonín Širůček in front of the pavilion Anthropos in Brno, slide “Slepička” (A Little Hen) in the premises of the kindergarten in the housing estate Invalidovna (after 1964) and climbing frame “Kyčelní kloub mamuta” (A Hip Joint of Mammoth) by Miloš Zet and Jaroslav Vacek also in the housing estate Invalidovna were created employing this method (16). Miroslav Jirava often used the method of backed concrete (17). “Torzo ženy” (A Female Torso) by Miroslav Jirava in Prague district Jarov (from 1965) represents this group. The torso is situated in front of the department store on the sloping grass surface next to the access stairs. An abstracted female torso (height 120 cm, width 105, depth 90 cm) is mounted on the pedestal with the following dimensions: height 30 cm, width 105 cm, depth 105 cm, combining concrete and sandstone. The statue is a hollow object created by application of cement plaster to the steel supporting structure, covered with ceramic wire lath, defining the shape of the object. Reinforcement cement is applied in two layers. Both layers are constituted by round aggregate (fraction 0–8 mm). The lower lighter layer is softer, strongly degraded on the bare points. The main manifestation of degradation is loess of surface and scaling. Plaster layers on the top summits of the statue are degraded to the ceramic wire and supporting reinforcement. The whole profile of the reinforcement is not completely exposed in any point; however, it is obvious that the cross-section is a smooth prism without ribs. On the sides, defects can be traced,

manifested as holes into the statue cavity, filled with municipal waste. There are several cracks in the statue and in the rain shadows is dark, most probably gypsum crust. Rarely, a white efflorescence can be seen on the statue surface. Moreover, the surface is polluted by dust deposits and by biological attack to a small extent.

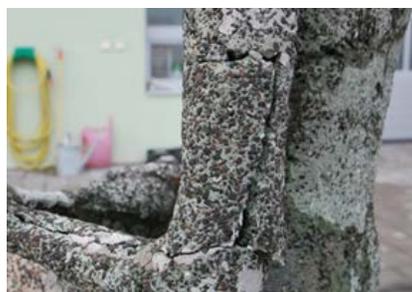
Fig. 10. Decorative wall in front of the primary school Labská in Brno, example of concrete casted pieces, engrained with used aggregate. Photograph Josef Červinka

Coloring of concrete pieces is an independent chapter of the survey. Concrete objects were colored applying several methods. Most commonly, natural color of surface was preserved, i.e., usually grey cement with used aggregate, defined either by technological specification or availability of aggregate in the particular locality. In the period of their birth, objects were grey in the tone of used cement; by protruding exposure of the aggregate (by surface weathering), pieces partially adapted to its coloring. Partial or complete application of the paint system was another possibility of the surface color treatment. Concrete object coloring was also achieved by the color throughout of the concrete mixture in the mass; either by pigments resistant to alkali or specially selected color chip stones. Miroslav Jirava used concrete colored in mass to build a climbing frame “Kohout” (A Rooster), installed in the playground in Krnov (1961). Paint, applied on the concrete surface, used (for instance) Alva Hajn to construct a decorative wall in the housing estate Dubina in Pardubice (1973; in cooperation with the architect J. Třeštík. Jan Koblasa applied paint, most probably imitating bronze, to the relief wall of the building of the former offices of the Československé aerolinie (Czechoslovak Airlines) in Ostrava (1965). A relief concrete wall made from concrete casted pieces, using light grey aggregate and red aggregate setting the color tone, can be found in front of the primary school Labská in Brno.

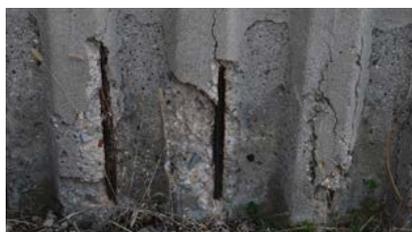
Fig. 11. Decorative wall in front of the primary school Labská in Brno, detail of combination of concrete casted pieces, engrained with used aggregate. Photograph Josef Červinka

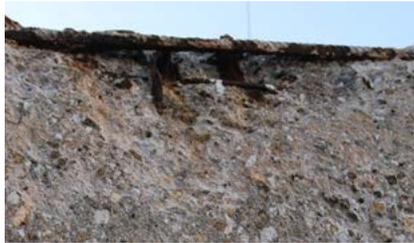
Fig. 13. Bohumír Matal, decorative wall with glass-mosaic cladding, Brno-Líšeň. Wall composition. Photograph Josef Červinka

the distance ca. 1 cm. Near this wall, another wall is situated with identical dimensions, without mosaic, but presented as concrete surface with pebblestone pouring on one side; it can be expected that the same wall was used to install the mosaic. Ribbed steel reinforcement with diameters 20 mm, 14 mm, 6 mm was detected inside the defects and opened segments discovered during the restoration. (Mosaic restoration with the partial transfer was carried-out in 2017–2018). Used concrete is formed by rounded and sharp-cornered aggregate (fraction 0–30 mm), bonded with grey cement. Mosaic cubes from sintered and cast glass (18) are fastened to the fine reinforced cement mortar. On the southern side, the upper edge of the mosaic panel is supported with the wire lath, folded under the cement rounded roof of the decorative wall. The southern side is enriched with mosaic decoration, aforeplaced for approximately 25 mm in front of the face of the panel, visible in the pedestal part not fitted with the mosaic. Dimensions of glass cubes oscillate from 17 to 21 mm. Sintered glass cubes were produced by the national enterprise Skleněná bižuterie in Jablonec nad Nisou. Poured glass cubes were produced in Jablonecké sklárny in Desná. Production ceased completely in the 1990's. Atmospheric deposits strongly contaminated the mosaic wall. Moreover, bed mortar of glass mosaic cubes was loosened; finally, some cubes have fallen off. Mosaic with bed mortar, separated from the concrete panel surface, have been lost in some parts. On the northern side, this phenomenon was so strong that the bed mortar and mosaic cubes were transferred. On the southern side, mosaic has been separated from its substrate for approximately 20%. Part of cubes, strongly fixed to the bed mortar, are either broken or cracked. Concrete panels are slightly dislocated to each other, on the western side for more than 10 mm. The extent of damage to concrete surface of panels is in the depth 0–10 mm (2% of the surface), in the depth 10–30 mm (1% of the surface), and in the depth 30–50 mm (0.5% of the surface). Exposed steel reinforcement (length 2 m) occurs on the panels. Exposed steel reinforcement demonstrates surface corrosion. Non-destructive strength measurement of the panel concrete in the pressure, adopting NDT method, with unguaranteed exactness, showed the values 26–38 MPa, i.e., the average value 33 MPa. Concrete carbonization depth was determined to the average of 4 mm (eight measurements). Covering layer of the concrete above the steel reinforcement is 36 mm in average. Tensile strength of concrete surface layers reaches 2.6 MPa. Adhesion strength of the mosaic to the concrete foundation is 2.3 MPa.

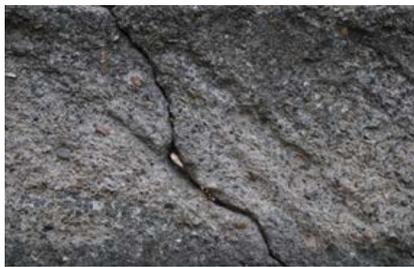
Fig. 14. Antonín Širůček, Lovec sobů (A Reindeer Hunter), Brno, concrete applied in three layers on the steel structure with wire lath. Last layer engrained with pigment and black aggregate additive.
